*Number*  
**WATRES DAM**

**NDS ID NO. PA-00451**

**PHASE I INSPECTION REPORT,**

**6 NATIONAL DAM INSPECTION PROGRAM.**

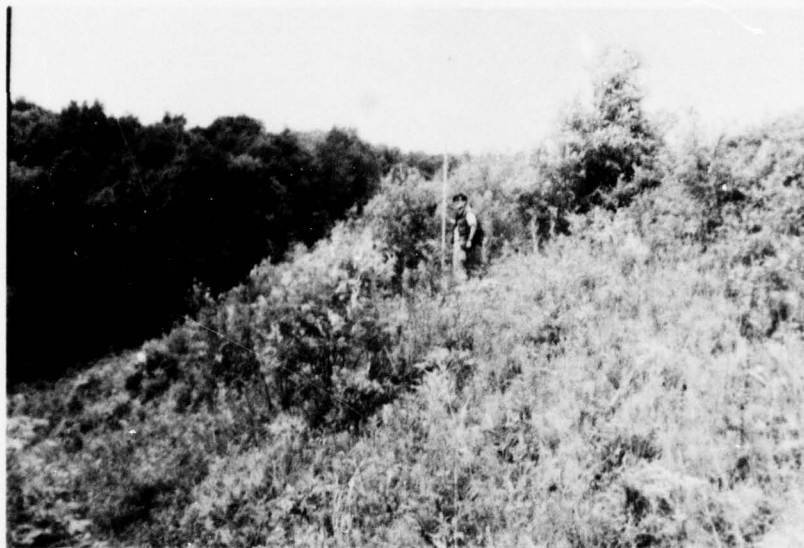
C. Brush on Downstream Slope of Embankment

(3) Remove brush from the embankment slopes and perform a detailed inspection to ascertain the condition of the embankment. Surveys should be performed to determine the existing template of the embankment. The results of the survey should be evaluated to ascertain if remedial action is necessary.

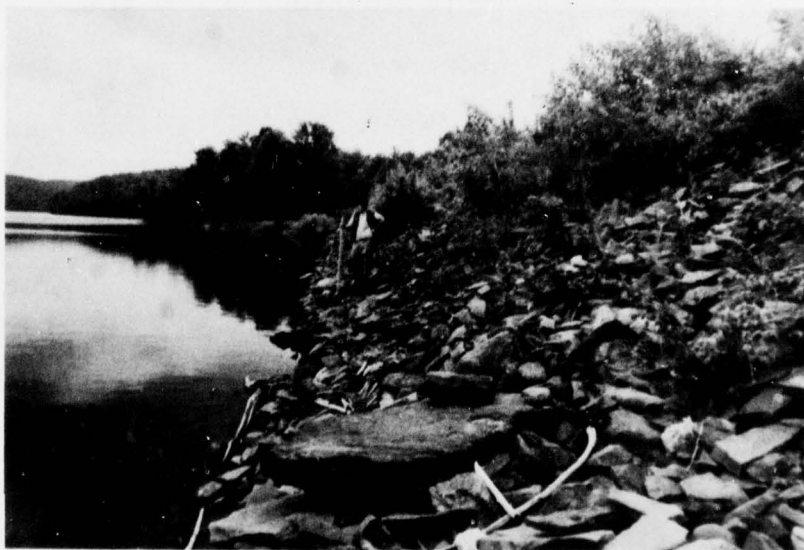
b. Embankment. The upstream slopes above the normal reservoir level appear to be in good condition, except for brush growing over the upper half of the exposed slope (Photograph D). The riprap appeared in good condition, with hardly any evidence of weathering. A survey performed for this inspection revealed that the lowest point on top of embankment is 1.1 feet below design elevation. The low area extends over 600 feet of the top. The left end of the low area is about 350 feet right of the left end of the embankment. The downstream slope was heavily overgrown with brush (Photographs A and C), except at the toe near the streambed. The toe in this area is rock fill. The abutment line was indistinct because of the heavy and, in some areas, impenetrable growth. One cross section of the embankment was surveyed for the inspection. To gain access to areas of the embankment, a path had to be cut with a machete. Because of the brush, many of the features shown on the section supplied by the Owner could not be seen. The surveyed cross section indicates that the embankment is somewhat steeper near the top than the Owner's cross section indicates. The survey revealed that the upper 20 feet of embankment is 1V on 1.3H or steeper. As changes in slope could not be observed, the survey data cannot be considered definitive. Most of the embankment could not be observed. The toe of embankment, at the streambed, was swampy (Photograph E). Two seepage areas were observed. About 30 feet downstream of the toe, on the right, clear water was seeping from the hillside at about 1 gpm. About 60 feet downstream of the toe, on the left side of the streambed, clear water was seeping at 2 to 3 gpm. Flowing water could be heard running through the rock fill at toe of dam. Access to the toe was through the woods from an access road about 200 feet to the left. Trees were growing adjacent to the rock fill at the toe. There did not appear to be any permanent watercourse from the swampy area at the toe to the stream.

D. Riprap on Upstream Slope of Embankment

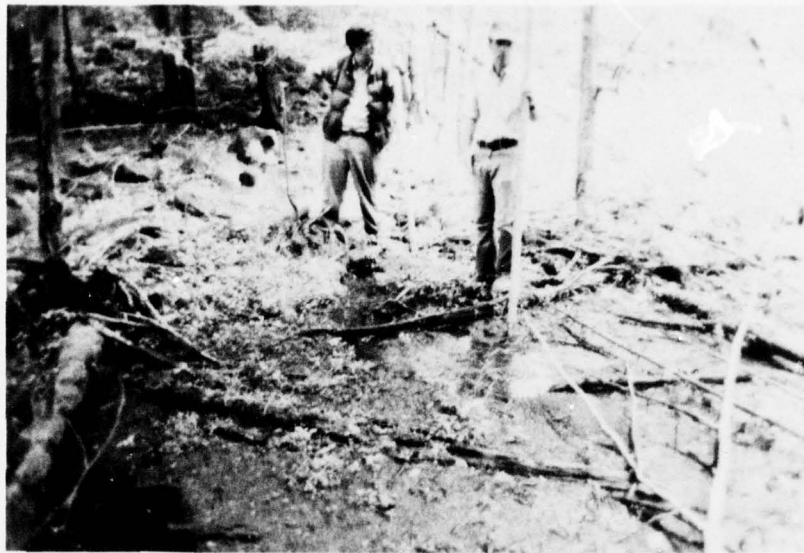
VISUAL EXAMINATION OF	OBSERVATIONS	REMARKS OR RECOMMENDATIONS
JUNCTION OF EMBANKMENT WITH: Abutment Spillway Other Features	No observable defects.	
ANY NOTICEABLE SEEPAGE	At toe of embankment-at old streambed-boggy area with two visible seeps. One 30 feet downstream of toe from right hill-1 gpm clear. Another 60 feet downstream from bottom-2 or 3 gpm clear.	Water can be heard flowing through rock toe. Access to toe only through woods.
STAFF GAGE AND RECORDER	None.	
DRAINS	Toe drain - see "ANY NOTICEABLE SEEPAGE" ABOVE.	
VEGETATION	Upstream slope - large bushes on upper half of exposed, ripped slope. Downstream - completely overgrown.	Recorder walked abutment line-with difficulty. Abutment line is indistinct with trees adjacent, two inspectors, one with machete required to take rod down for section stadia. Not a thorough inspection.

E. Seepage at Toe of Dam

(4) Provide positive drainage and good vehicular access at toe of dam to aid in assessment of seepage. Install at least eight observation wells, or other instrumentation, downstream of the axis of the dam. One well, or other instrumentation, should be located in the vicinity of the seepage. The others should be at appropriate locations to determine general water level in downstream embankment. The number of wells, or other instrumentation, will be dependent on the results of the inspection recommended above. Data collected from observation wells or other instrumentation should be utilized in evaluating the stability of the structure and assessing piping potential in the future. Continue to observe wet areas and seepage downstream from dam. If conditions worsen, appropriate action should be taken to control apparent seepage with properly designed drains.

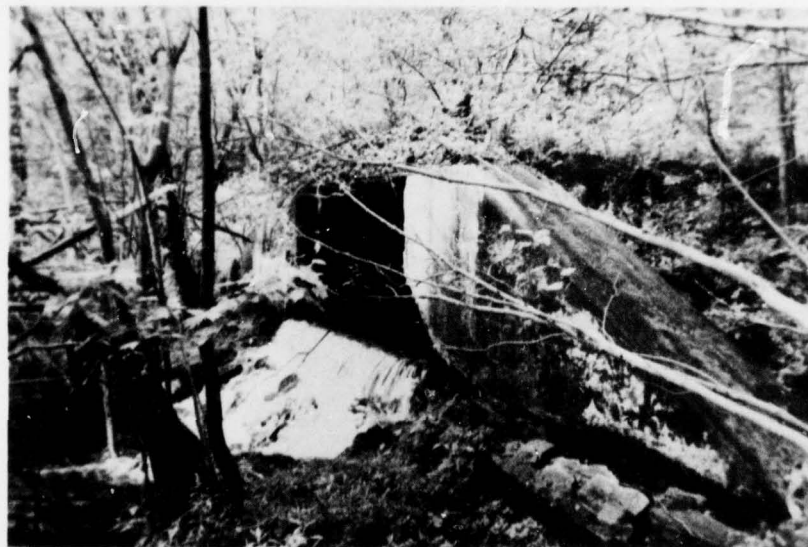
c. Outlet Works. The inoperable floatwell presents no hazard to the dam. However, if operable it would be an aid, in assessing the seepage downstream. The rusting ladder could eventually be a hazard to personnel. The leakage observed in the tunnel presents no significant hazard to the dam. The deteriorated headwall does not present a hazard to the dam.

F. Headwall at Downstream End of  
Outlet Works Tunnel

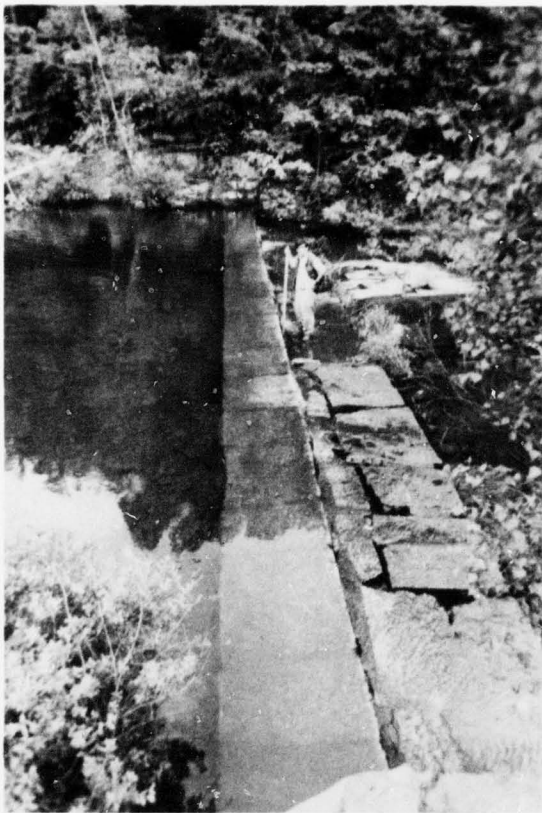
c. Spillway. Mortar is missing for up to a 2-inch depth from some joints in the weir and downstream apron (Photograph G). There is a small amount of vegetation in the channel immediately downstream of the weir (Photograph H). The stream below the spillway channel has dead trees strewn across it (Photograph I). The masonry retaining wall on the right bank in this area has deteriorated mortar, with

b. Spillway. The deterioration of the mortar is not sufficiently serious to be of concern. The vegetation downstream of the weir is too small to create problems at present. The trees in the downstream channel, while not desirable, present no significant hazard to the dam. Trees adjacent to the retaining wall are undesirable. Long-term neglect of the deteriorating mortar could prevent the spillway from acting as a watertight structure.

G. Spillway Crest

- (1) Remove trees close to slopes.
- (2) Visually monitor vegetation in spillway channel and clear vegetation when warranted.
- (3) Repair deteriorated mortar in masonry joints.
- (4) Remove trees close to retaining wall near spillway channel.
- (5) Clear downstream channel of dead trees.
- (6) Visually monitor leaks in outlet works tunnel and take remedial action should conditions worsen.
- (7) Repair concrete at downstream headwall of outlet works.
- (8) Repair or replace, and maintain the monitoring equipment, bent gate stem and ladder.
- (9) Investigate if the beaver dam in the downstream channel is causing the swampy conditions at toe of embankment. If it is causing this condition, it should be removed.

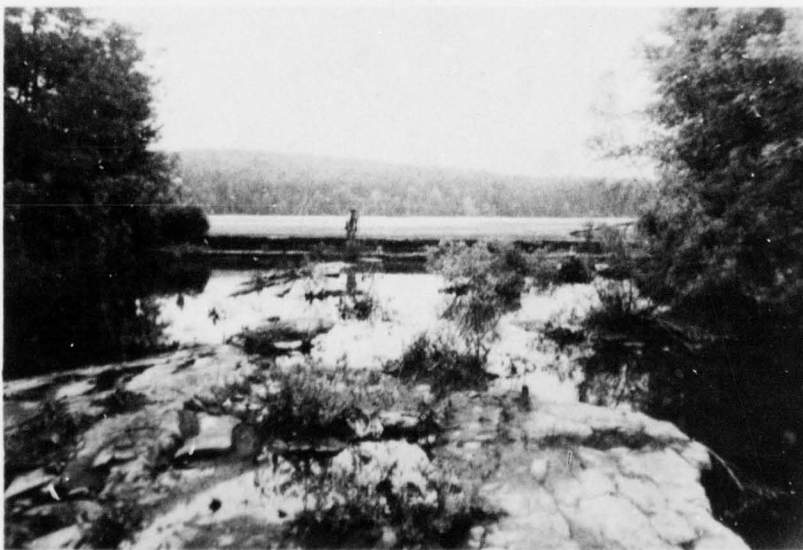
H. Spillway — Looking Upstream

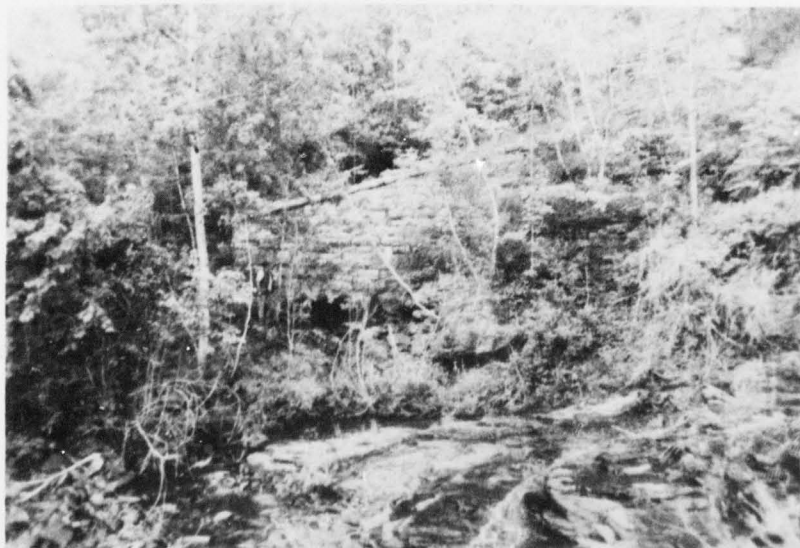
grass growing in some joints (Photograph J). A brown-colored leaching was observed over the lower half. Trees are growing close to this wall.

J. Retaining Wall on Right Bank of  
Downstream End of Spillway Channel
